MATRIX TROUBLESHOOTING

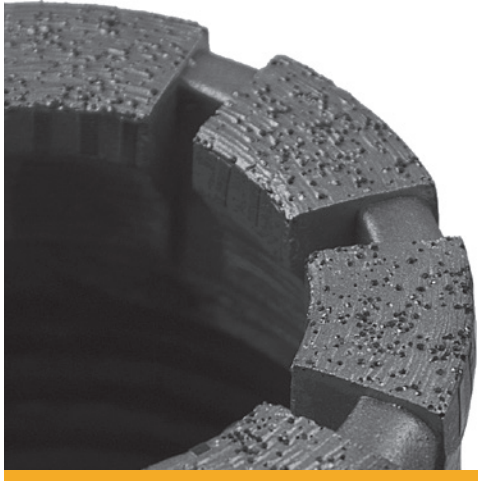
IDEAL WEAR

Even wear to the carbides with the diamonds evenly worn.

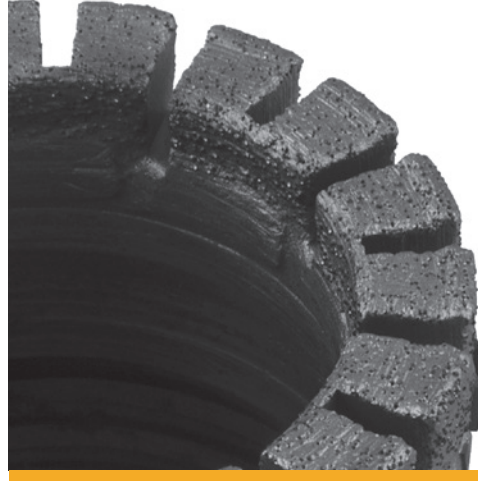
DIAMONDS OVERLY EXPOSED

Matrix wears before diamonds have worn out. Diamonds pop out prematurely, reducing bit life.

Caused by:

- Drilling pressure too high for the speed of rotation
- Water flow is too low
- Matrix used is too soft

Solutions:

- Increase speed of rotation and reduce the drilling pressure
- Increase the water flow
- Change the bit for a lower series (harder matrix)

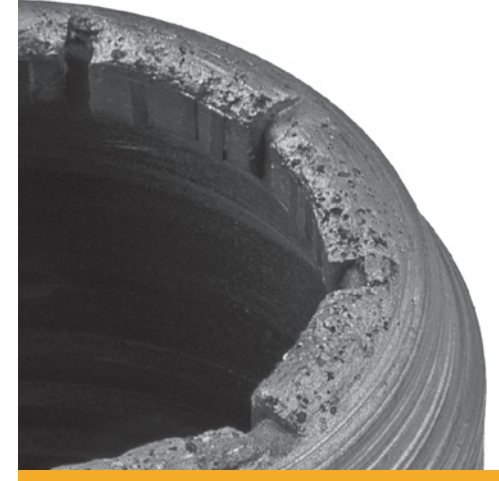
BURNT

Matrix has completely melted, waterways are closed.

Caused by:

- Water ran out
- Poor water circulation

Solutions:

- Increase water flow
- Check if the pump is working well
- Check the rods for leaks in the joints
- Confirm whether the inner tube is too long and adjust, if necessary

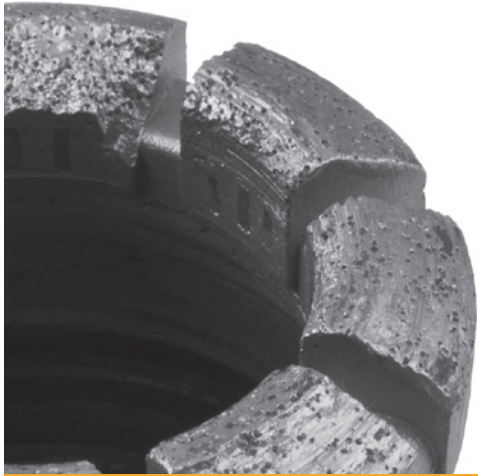
CORE BIT POLISHED OR GLAZED

Bit doesn't cut and diamonds appear polished.

Caused by:

- Drilling pressure too low for the speed of rotation
- Water flow too high
- Matrix used is too hard

Solutions:

- Sharpen the bit
- Reduce the rotation speed and increase drilling pressure
- Reduce water flow
- Select a bit from a higher series (softer matrix)

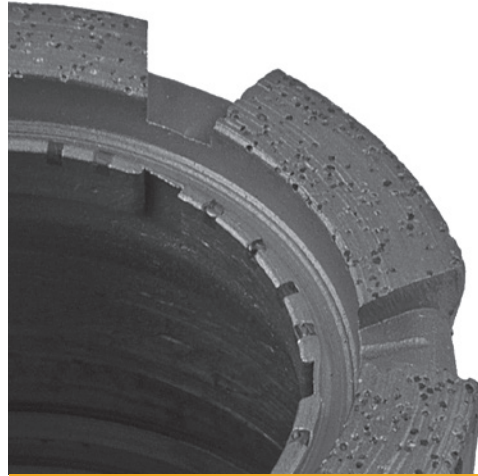
I.D. GAUGE LOSS

Wear of inside diameter and inside ringing. Concave wear pattern.

Caused by:

- Drilling pressure too high
- Very broken ground
- Core left in the hole
- Water flow too low
- Matrix too soft

Solutions:

- Increase rotation speed
- Reduce drilling pressure
- Change for a lower series core bit (harder matrix)
- Increase water flow
- Check and adjust the length of inner tube

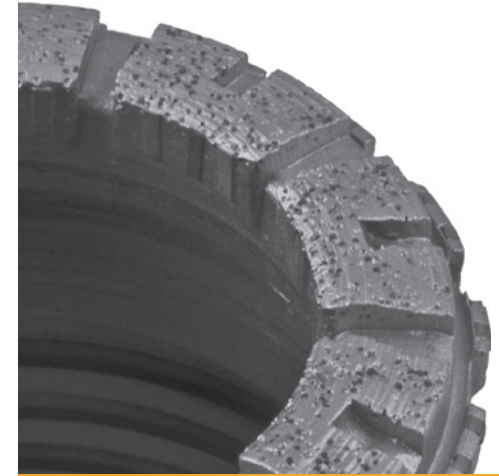
O.D. GAUGE LOSS

Wear of outside diameter and outside ringing. Convex wear pattern.

Caused by:

- Vibration
- Rotation speed too high
- Water flow too low
- Cave in, the hole was reamed

Solutions:

- Increase water flow
- Reduce rotation speed
- Check the diameter of reaming shell
- Add drilling fluids (to reduce vibration)
- Try new configurations (deep lateral discharge or deep water way)

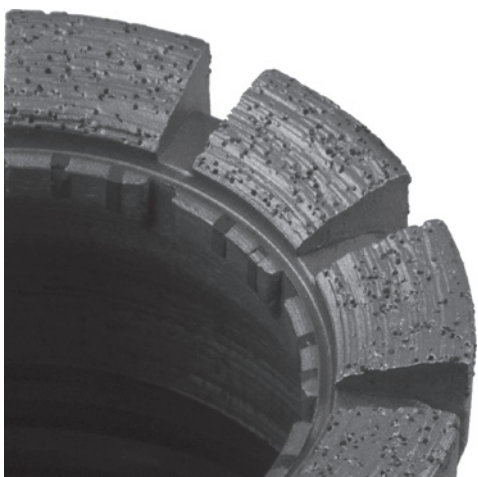
INSIDE WEAR PATTERN

Inside of the bit has worn down before the outside, in a concave pattern.

Caused by:

- Drilling pressure too high for the rotation speed
- Core left in the hole had to be drilled
- Very broken ground
- Core blocked in the inner tube

Solutions:

- Decrease drilling pressure
- Increase rotation speed
- Check and adjust the length of inner tube
- Add drilling fluids (fractured ground)
- Don't try to push through a core block

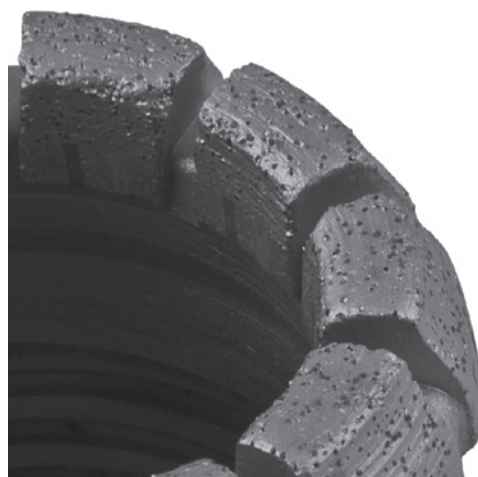
OUTSIDE WEAR PATTERN

Outside of the bit has worn down before the inside, in a convex pattern.

Caused by:

- Water flow too low
- Loss of water by the rods
- Hole "reamed"

Solutions:

- Increase the water flow
- Check for leaks
- Check the diameter of shell
